Re 1936 SUNBEAMS.

THE DESIGN OF THE REAR HUB ON THESE MODELS IS INCORRECT.

1936 SUNBEAM REAR WHEEL.

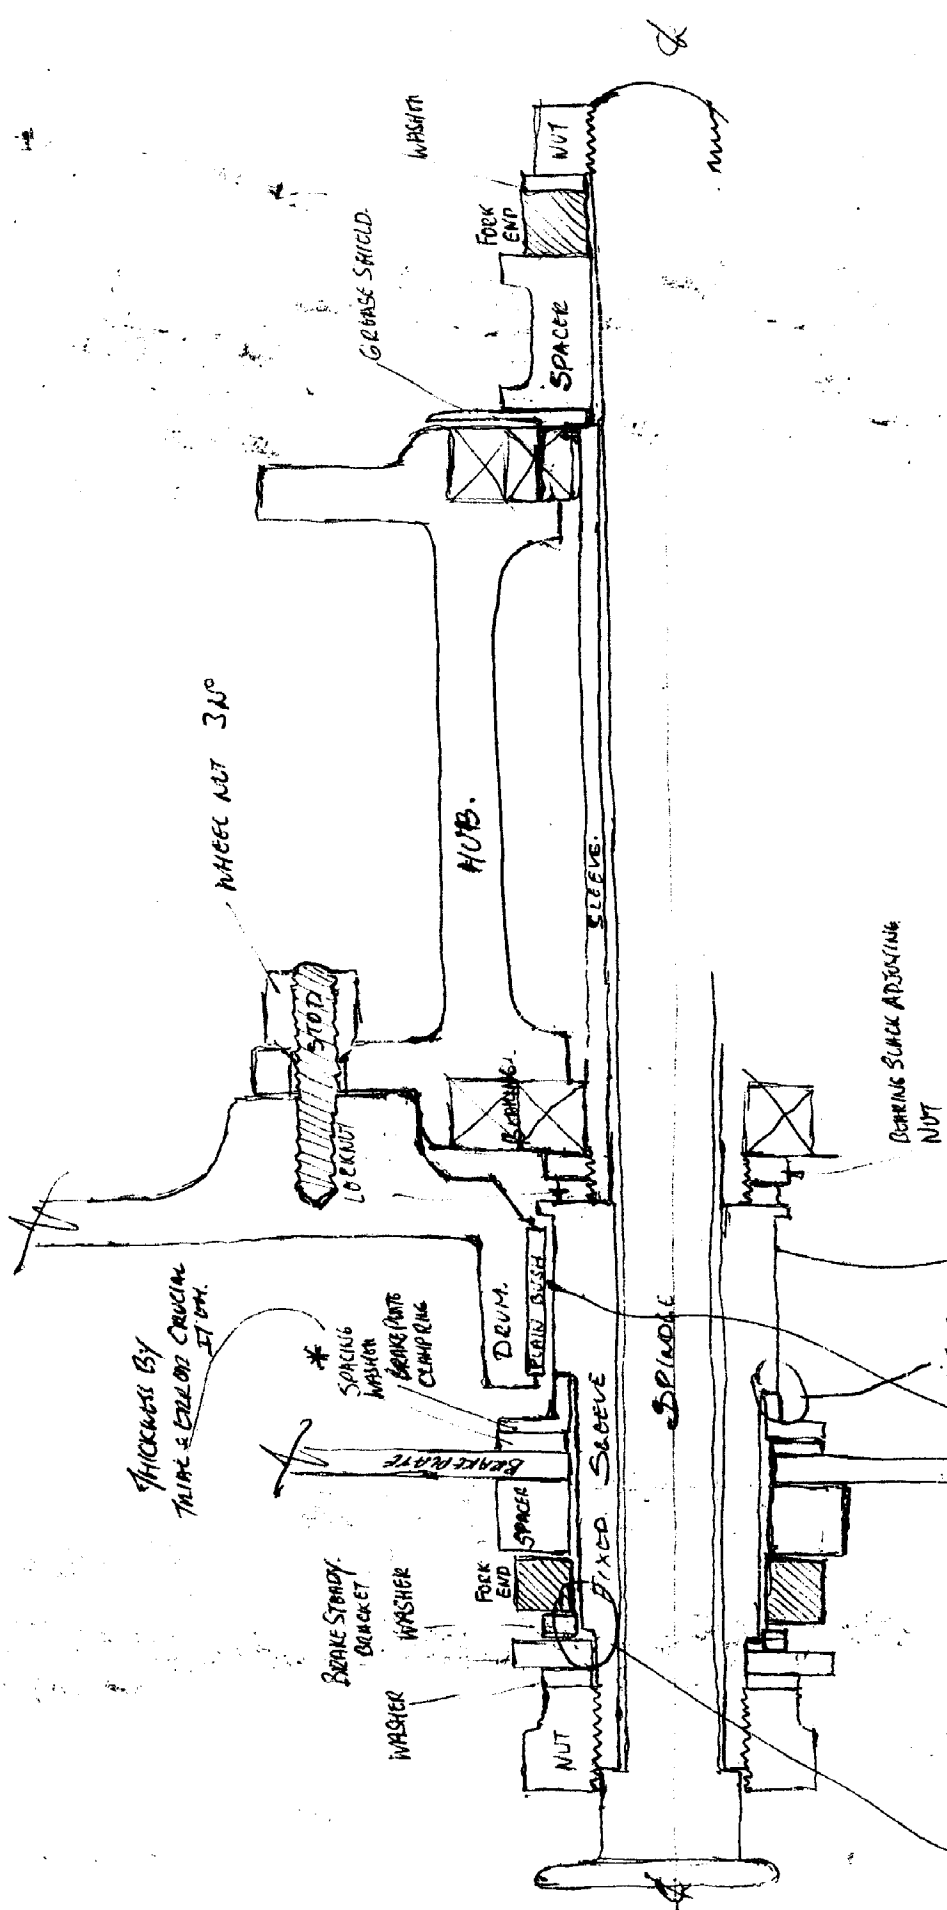
REAR WHEEL DETAIL.

THE SECRET IS THAT ALL PARTS ON THE FIXED SLEEVE PULL UP TIGHT WITH THE SLEEVE NUT & THE WHEEL SPINDLE PULL UP TIGHT FROM THE OTHER END. & THE DRUM IS SUSPENDED BY THE 3 WHEEL NUT STUDS TO THE HUB & THE DRUM TOUCHES NOTHING & THE WHEEL BEARING HAVE WORKING TOLERANCE & THE DRUM STILL TOUCHES NOTHING

CLEARANCE

SAY .020" MIN.
