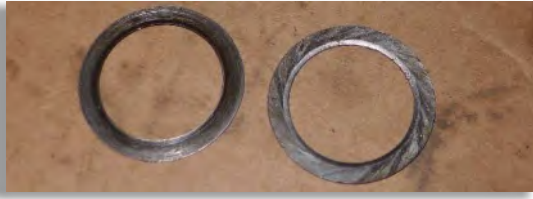
Figure 47: One shim was installed on each side of the main roller bearing for end float adjustment. The thicknesses here are 0.014" (0.365mm) and 0.015" (0.385mm).

On both sides of the large roller bearing on the drive side there were thin imperial shims on the shaft (Fig. 39 and Fig. 47). We also found a metric shim on the inner side of the timing roller bearing. This shim was compressed, torn and was significantly larger than the shaft diameter of 22 mm (Fig. 48). These washers were installed at the factory to adjust the end float and, if necessary, must be adjusted to re-set this float.

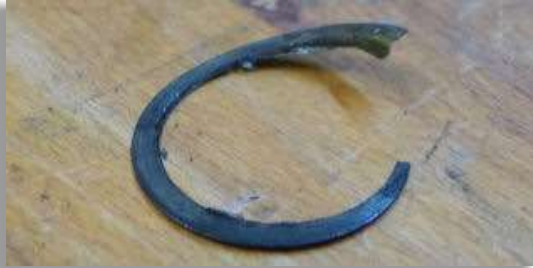
Figure 48: The compressed and torn shim on the inner side of the timing roller bearing.

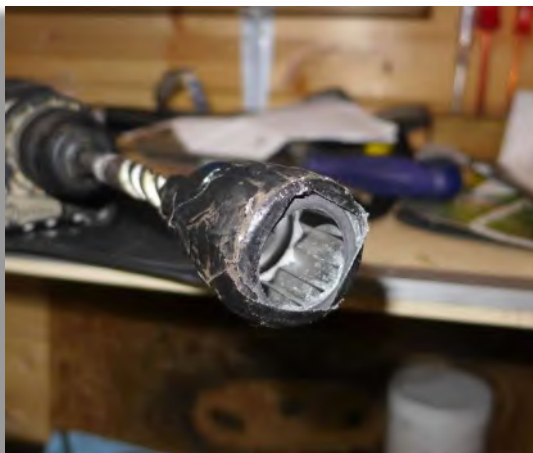
Figure 49: A shim fixed to a hexagonal nut with adhesive tape.

Imperial shims for the driving side seem to be impossible to get in Europe (the shaft has 1 inch diameter) whereas it is easy to get metric shims for the timing side. Even in the UK they had changed to metric sizes⁴. One can increase the inner diameter of metric shims to inch sizes, though. This can be done with rudimentary tools. We taped a shim onto a large hexagonal nut (Fig. 49), connected it with a drill and enlarged it with a file by fast revs (Fig. 50).

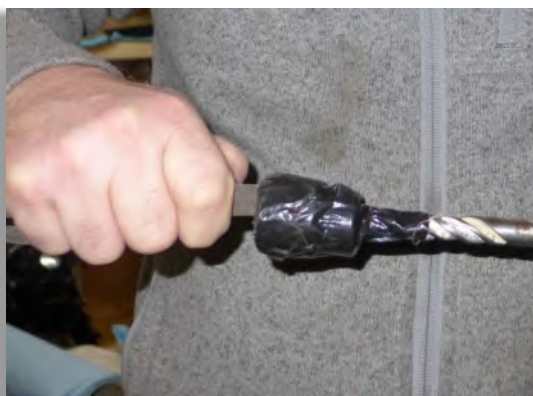
Figure 50: At high revs, the inner diameter of the shim is enlarged with a half-round file.

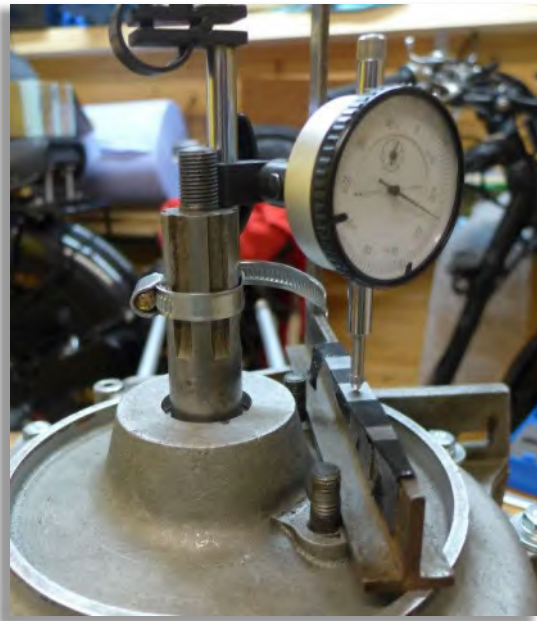
Figure 51: The gauge attached to the shaft.

First, we had to define a uniform method of measurement. For doing so the dial gauge was attached to the shaft and the height of various points on the case was measured (Fig. 51). Then the case was carefully removed from the wooden blocks and placed on the axis. The measurements were repeated. A second series of measurements was taken with the dial gauge on the crankcase and the height of various points on the crankshaft was measured (Fig. 52). The different measurement methods initially only served to find a reliable method in the first place that delivers repeatable results. Only when such a method has been found can the measurements of the end float be carried out with it. We decided on the procedure in figure 51 and stuck to it for all measurements.

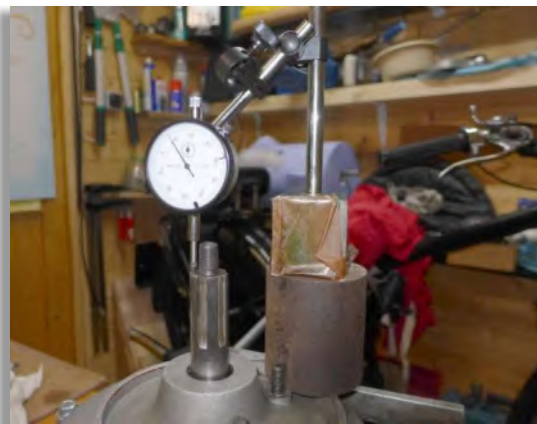
Figure 52: The gauge positioned on the crankcase.

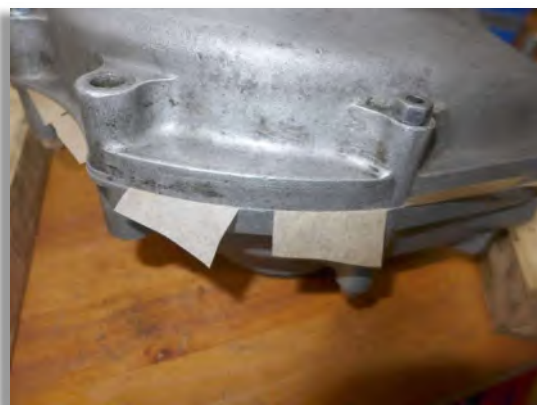
Figure 53: Testing for the correct end float with 2 thou backing paper.

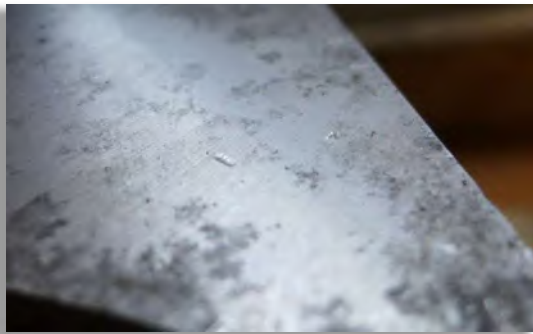
Figure 54: Part of the crankcase sealing surfaces. It represents the most disturbed part. The other surface parts look better.

From the Marston Club we got information that the their crankcases didn't have a gasket installed. Of course, we wanted to be sure if a gasket was needed. Imagine the crankcase is leaking when everything is reassembled... Because we did not get a definitive answer for the 1937 year of manufacture, we decided to trust the expertise of the old engineers and do without a gasket. This was supported by the good surface quality of both halves. The crankcase has already at least once been opened and the last person who had opened it certainly applied the gasket. But dents and scratches were only local. One could still easily see the machining traces from the manufacture (Fig. 54).

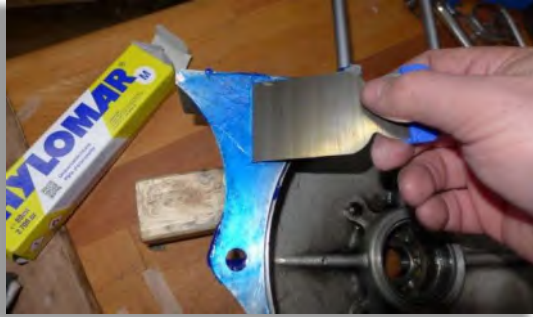
Figure 55: Applying the non-hardening jointing compound Hylomar M to the two crankcase parts.

After cleaning the surfaces with alcohol one should use a small scraper to apply a coat of Hylomar to both surfaces (Fig. 55). One does this in one go as it is not easy to go back over an area (Fig. 56). The halves are then torqued diametrically again to 10, 15 and then 20 lb.ft to estimate the final end float.

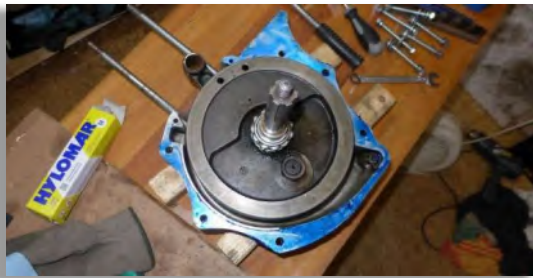
Figure 56: The crankcase just before being closed.

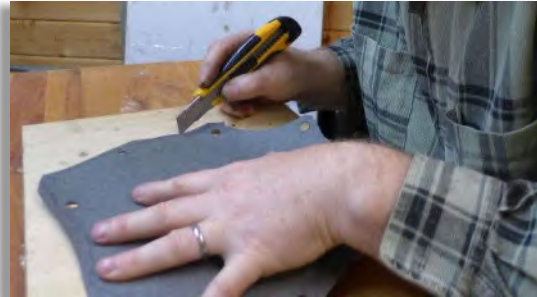
Figure 57: Cutting a new gasket.

Paper seals are used at several locations: At the covers of the upper and the lower rocker box, at the cover for the timing chain, at the connection between inner primary chain case and crankcase and at the cover of the primary chain case. Gasket paper can be purchased cheaply and the gaskets can be cut from gasket paper using a cutter (Fig. 57). For a reliable sealing effect, a non-hardening sealant (e.g. Hylomar) is recommended, which is applied thinly to the gasket before assembly.

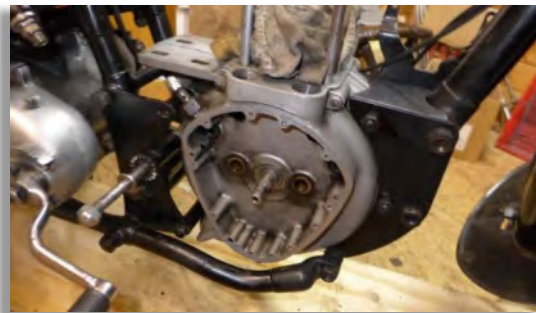
Figure 60: The crankcase back in the frame.

With the help of the pictures and notes taken during disassembly one now goes back step by step towards the rebuild (Fig. 60).

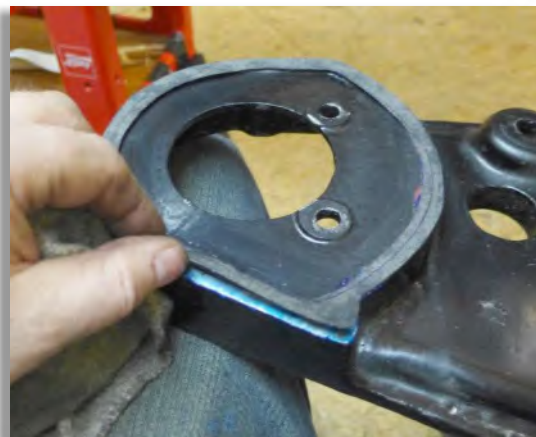
Figure 61: The new gasket between the crankcase and the inner primary chain case is embedded in Hylomar.

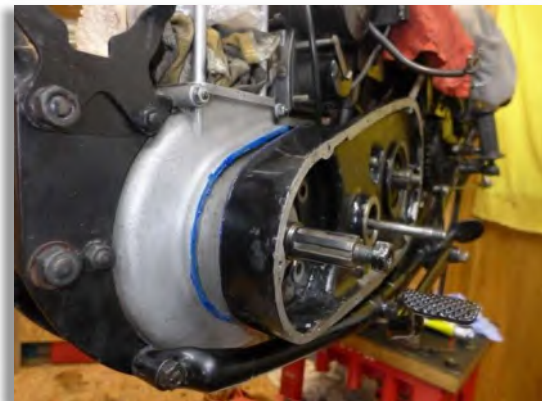
Figure 62: Assembly of the inner primary chain case.

First, the magdyno unit can be screwed back onto its platform behind the cylinder. The primary chain case can then be attached to the installed crankcase. A gasket was found between the two during disassembly. We replaced it, coated it on both sides with Hylomar M (Fig. 61), attached the inner primary case again (Fig. 62) and reinstalled the clutch.

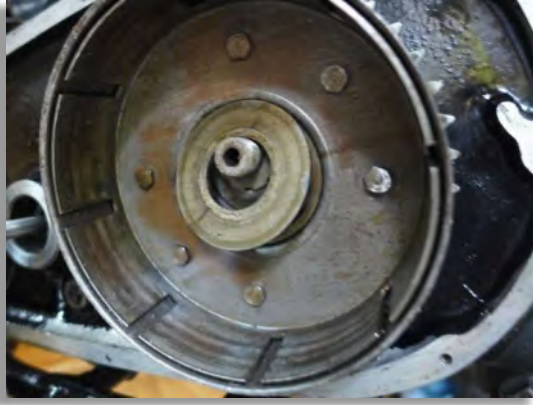
Figure 63: The loose front washer inside the clutch which covers its roller bearing. The respective back washer has a larger thickness.

Caution: As noted above the rollers of the clutch roller bearing are freely moving in a housing consisting of hardened steel thrust washers that take any side forces of the clutch basket assembly. The washers and rollers need to be greased when re-fitting. The back washer has a larger thickness than the outer one. If confused the back washer will scratch on the sprocket hole rim of the inner primary chain case (Fig. 63).

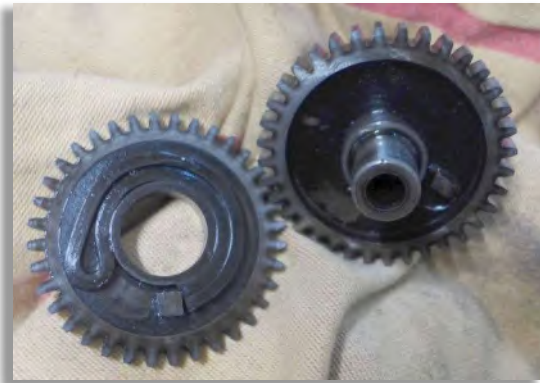
Figure 64: An open camshaft with the internal spring mechanism.

On the timing side the central timing gear and the two camshafts are now reinstalled. The gears of the camshafts are divided into two parts (Fig. 64). In their cover there is a spring mechanism in which a finger engages. This mechanism can be used to preload the cover slightly by turning the finger on the spring (Fig. 65). It stops the gears making noise between being loaded and unloaded. It keeps the gears engaged in the same direction at all times, rather than the teeth chattering to and fro. This happens in the valve train after the load increase to open the valve, followed by a slackening after the cam lobe peak has been reached. It doesn't control the valve opening/closing, but only reduces the noise in the valve gear. So the drive is being taken through the gear with the peg and the rattle is being taken out by the gear with the spring.

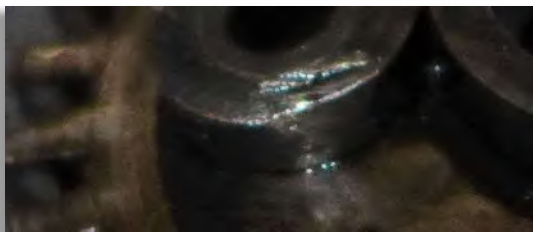
Figure 65: Traces of the internal finger on the spring.

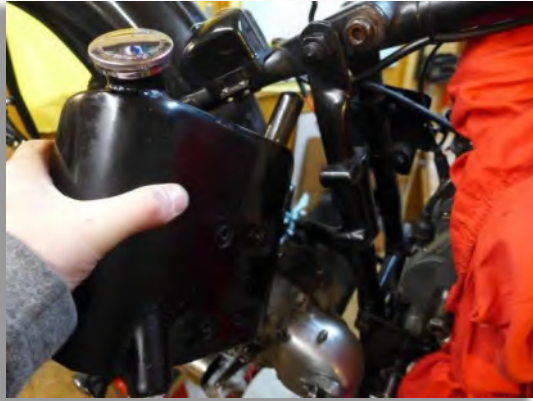
Figure 66: After loosening the four tank mounting bolts, the tank can be pulled out to the side.

Before installing the cylinder magneto unit, one should make use of the simplified access to the oil tank to remove and clean it. For the 1937 Model 9 this is easy and straight forward. Loosen the four tank bolts on the frame and pull the tank out to the side (Fig. 66).

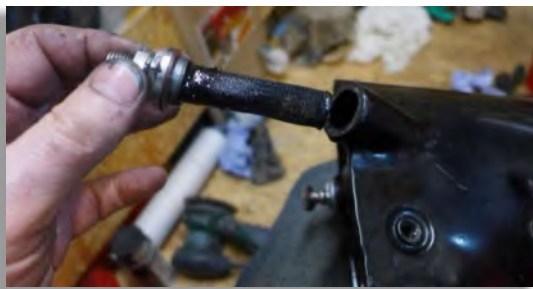
Figure 67: The oil feed plug with a mesh filter.

In addition to the filling hole and the drain plug on its side, the oil tank has three ports on the bottom - the feed plug to the engine with a mesh filter (Fig. 67), the return plug with a bent pipe (Fig. 68), and the vent plug with a straight pipe (Fig. 69).

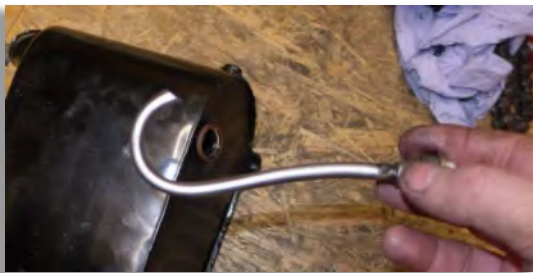
Figure 68: The oil return plug with its pipe.

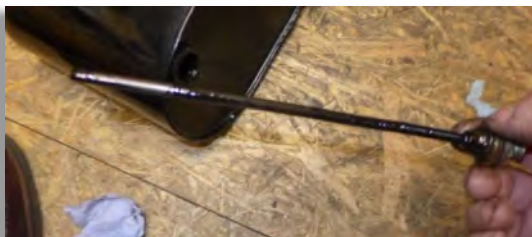
Figure 69: The tank breather plug with its straight pipe.

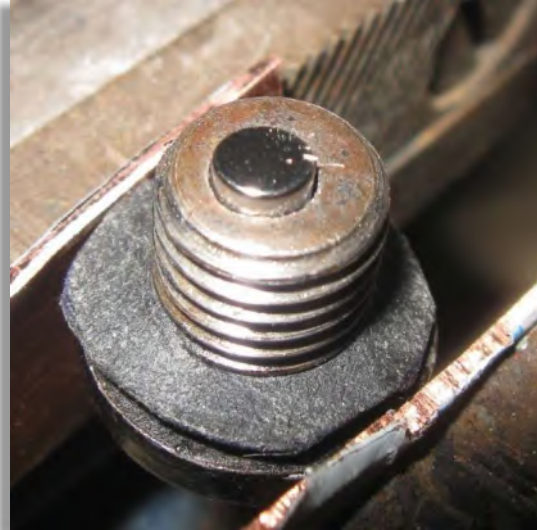
Figure 70: A Neodymium magnet in the oil plug.

Long before removing the tank, we had attached a small but strong Neodymium magnet to the drain plug to remove metal chips from the oil circuit that inevitably result from engine abrasion (Fig. 70). Shaking the tank with paraffin, old metal chips stuck in the oil mud were now stirred up and held in place by this magnet (Fig. 71). Without a magnet, such metal residues travel unhindered in the oil circuit and lead to increased wear.

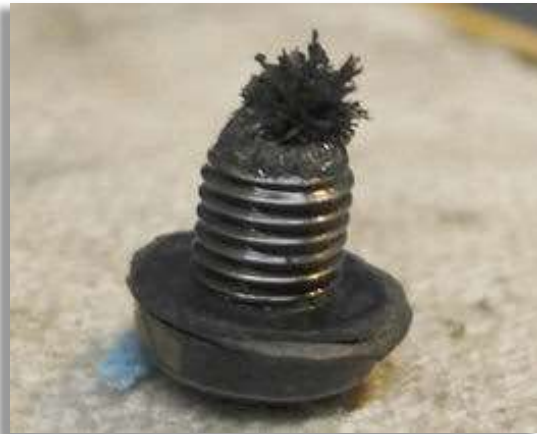
Figure 71: Metal chips on the magnet of the oil drain plug.

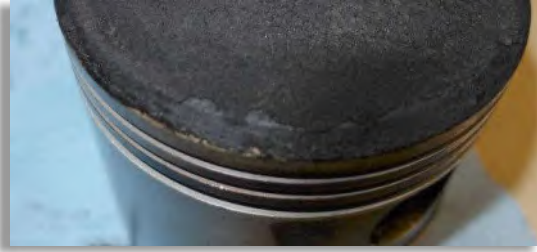
Figure 72: A strongly carbonized piston.

The piston is one of the fast moving motor parts and considering our initial problem (spring resonances) the piston should be scrutinized. As a rule, carbonized residues have settled on the upper side of the piston, which can be quite thick (Fig. 72). These residues are removed with a brass brush. The surface is then polished to prevent residues from re-setting quickly. In the present case we found a standard size piston from SPECIALLOID. Either it is the original from 1937 or the cylinder has a cylinder liner to compensate larger bore after successive installation of oversize pistons. However, there was no liner. That means that the engine was still running on its 83-year-old first piston! A clear sign of very low mileage. The piston size was 79.84mm and the bore had 80.07mm. The piston did not show significant wear or scuffing and the bore did not show significant scoring. New piston rings are recommended in any case. The previously used piston rings often no longer sit planarly on the cylinder running surface due to wear, so that their compression effect is reduced. And in our case the oil ring had a gap of 55 thou (1.4 mm) which is far beyond any acceptable limit (see below). It might well be that the rings were not the original ones as the gaps were far too great. After some searching, suitable rings were ordered from Cox & Turner Engineering⁵. Note that Cox & Turner rings have the benefit of being marked 'top' which helped with fitting them correctly during reassembly.

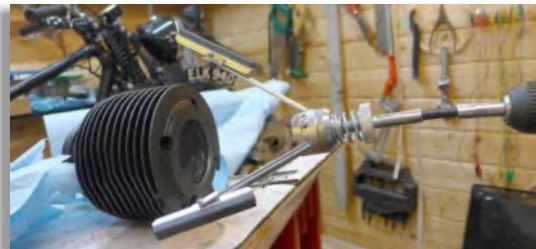
Figure 74. A cheap honing tool breaks the glaze with its three grinding heads.

In addition, the cylinder running surface is often glazed and oil can no longer wet it well (Fig. 73). For this purpose, the running surface is briefly ground with a low-cost honing tool in a cordless screwdriver (movements up and down to provide a helical pattern) to roughen it again (Fig. 74).

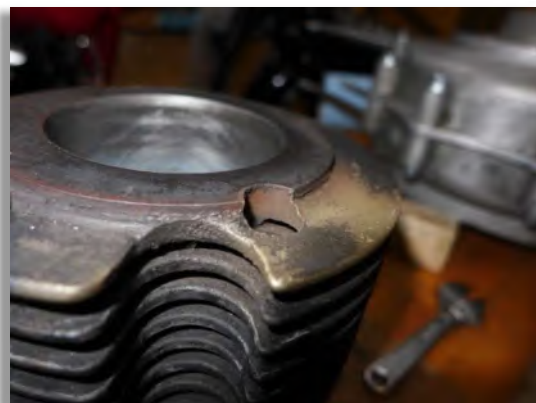
Figure 75: A bronze cylinder surface appeared after using a brass brush for cleaning the fins.

We wanted to re-paint the cylinder with black cylinder paint. Before doing that its surface must be cleaned by getting the old paint and grease off. Interestingly, a bronze surface appeared after using a brass brush to the fins (Fig. 75). That was puzzling and unexpected. A test with a magnet showed that the barrel is out of cast iron.

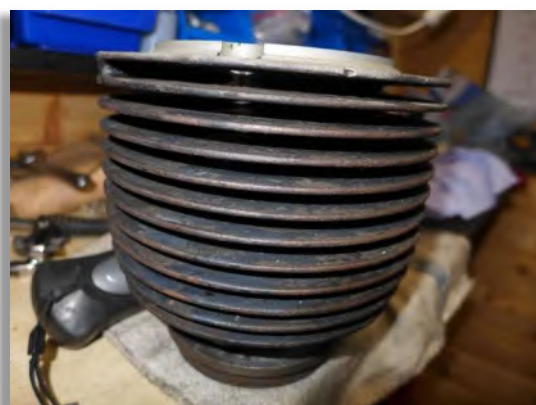
Figure 76: The cylinder after the bath.

Instead of continuing blasting we tested an interesting cleaning alternative found in the internet. Dimethyl Sulfoxide (DMSO) is a widely used solvent in laboratories and engineering, nontoxic, relatively cheap and easy to purchase. We mixed one liter with about five liters of warm water (DMSO crystallises at 18.5 °C), about 200g of pure sodium carbonate (washing soda) and plenty of dishwashing liquid and put the cylinder in this liquid for a few hours. The liquid almost completely removed the paint (Fig. 76) and we could finally paint it with cylinder paint.

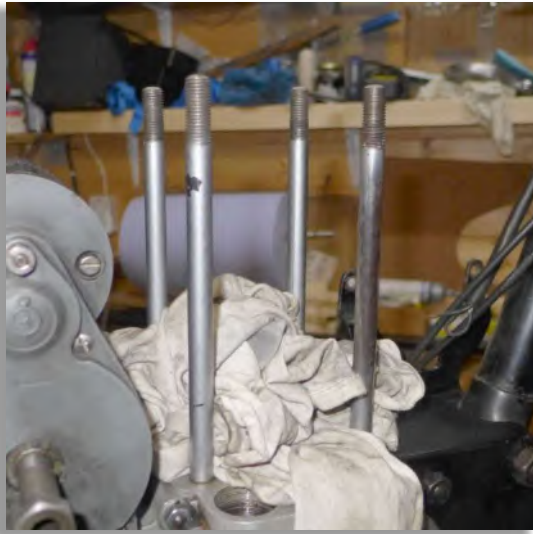
Figure 77: The chrome surface of the front right cylinder stud in poor condition.

One of the front cylinder studs has seen the weather and not had the oily film that maybe protected the others (Fig. 77). From a fellow driver we were told that the studs are satin chromed. Unfortunately, the chrome is one of the most expensive surface application and we got price information of at least 200 GBP for a single bolt. For that reason we opted for 2-component high temperature brake caliper paint in matte silver for a tenth of that price (Fig. 78).

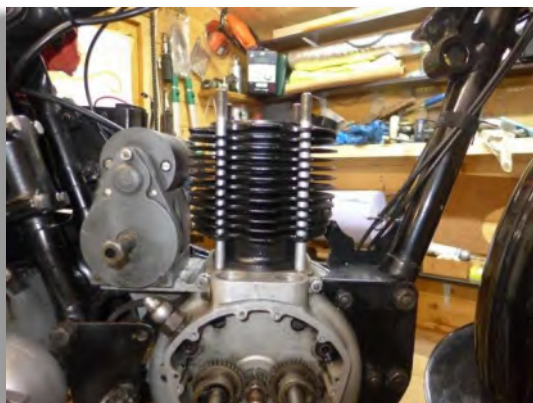
Figure 79: The assembled cylinder.

Now with a 0.5mm paper gasket at its base the cylinder can be assembled by carefully sliding it onto the bolts and onto the piston (Fig. 79).

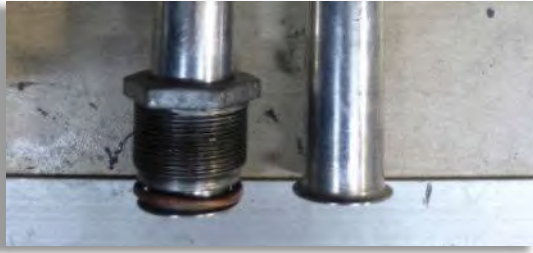
Figure 80: The bases of the two pushrod tubes. Left with its respective gasket-sealed connector to the crankcase.

We separated the tubes for the pushrods from their flanges to polish them and to be able to remove the upper copper gaskets at their base (Fig. 80). Since they were compressed by their installation, it makes sense to soften them by annealing and quenching, as with any copper gasket before installation (Fig. 81). The lower tube ends both sit on a second copper gasket which again sit in the crankcase (Fig. 82). However, since these were firmly in place and could not be removed without risk of damage, we left them untouched. A little Hylomar ensures sufficient oil tightness.

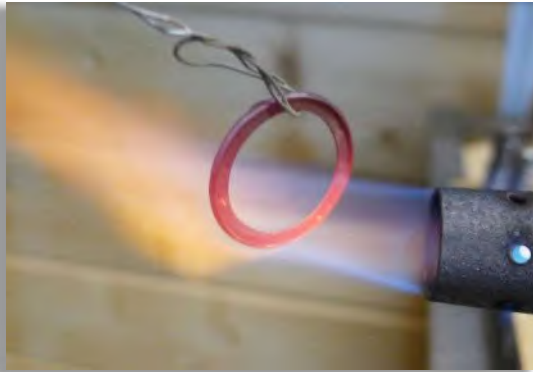
Figure 81: Annealing the copper gasket of the pushrod tube.

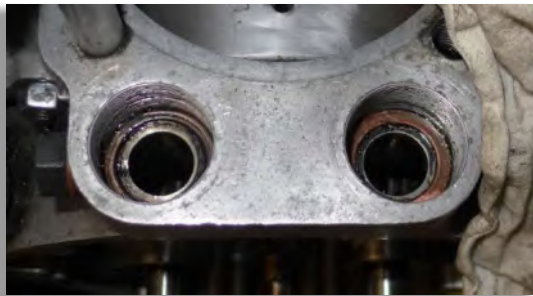
Figure 82: The copper gaskets in the holes for the pushrod tube connectors. They are left untouched because they are pressed firmly into their seats.

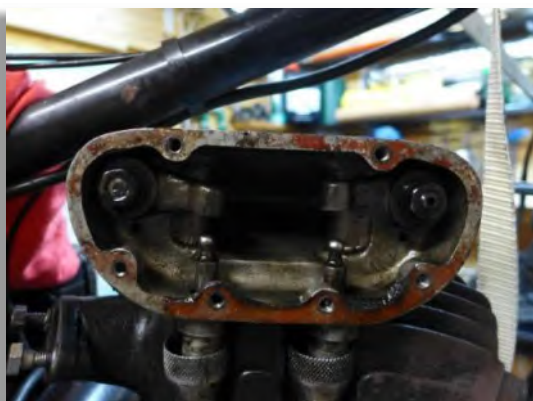
Figure 84: The upper rocker box between upper frame tube and cylinder head. Note the two pushrods intruding the box.

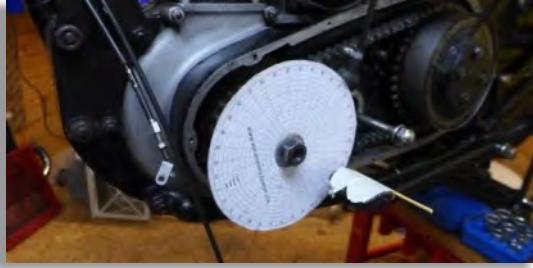
Figure 85: The timing disc on the crankshaft driving side.

To avoid this path, one can fix a timing disc on the crankshaft (Fig. 85). It can be downloaded from the Internet and printed out. Together with a pointer we installed to the brake pedal then "translates" the correct piston position (here 9/16" BTDC⁷) into the desired angle (here 43°) at which the contacts of the magneto must open at fully advanced timing to generate the ignition spark (Fig. 86). The angle of 43° does not have to match exactly to the length of 9/16". In our case it is 41°. With slow carbonization (Fig. 72), the values inevitably change a little. It might well be that the 9/16" was the closest Imperial measurement to the required 43° (Fig. 87). That way a 9/16" spanner could be used to provide the measurement to mark a piece of wire from which the depth could then be set through the hole for the spark plug - no ruler or caliper required⁸. Note that allocating top dead centre with the respective rotation angle at the crank shaft is somewhat delicate, anyway, since the piston moves by only about half a millimetre within a 10° angle around TDC for a 100mm stroke. This is the reason why one should first adjust the piston position and then setting a timing disc to the desired angle.

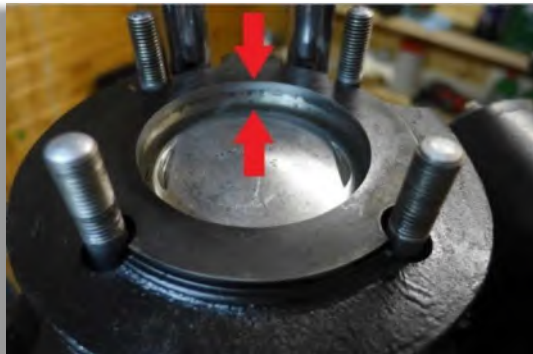
Figure 87: 9/16 inch before top dead centre.

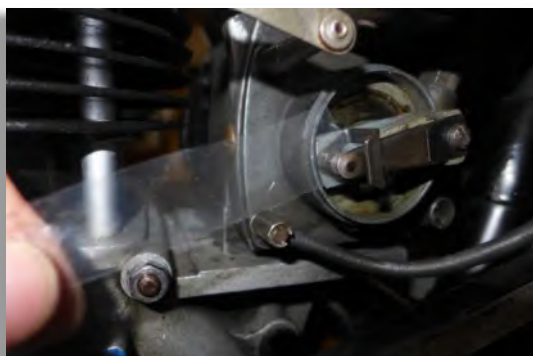
Figure 88: Cellophane sheet between the magneto points. As soon as the points open one can pull out the sheet.

With this setup one will be able to accurately adjust the timing after assembling the timing cover together with the pushrods and the cylinder head (see next chapter). It is clear that the disc should not be moved again after the correct timing positions are fixed. The exact position when the magneto contacts open can then be adjusted by the upper timing chain sprocket sitting on the conical magneto axis. To get the point where the contacts open one can use a thin piece of Cellophane sheet between the points. As soon as they open one can easily pull out the sheet (Fig. 88).

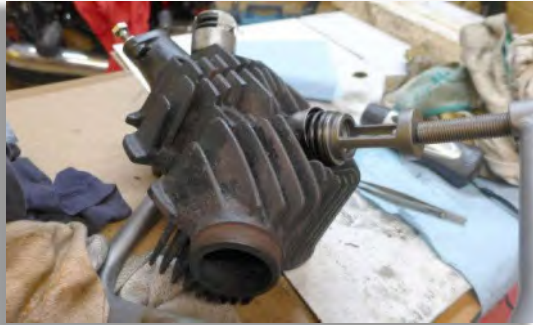
Figure 89: Removing the valves with a suitable tool.

As the cylinder head is not easily accessible, it is worthwhile scrutinizing all parts. This means that the valve dimensions and those of the seats and guides should be checked. An appropriate tool for removing the valves is available in the Internet for little money (Fig. 89). **Caution:** The valves are held by two conical collets (Fig. 90), which can easily fall out and get lost when the valve springs are compressed. Since these collets are hard to get, one should take good care of them!

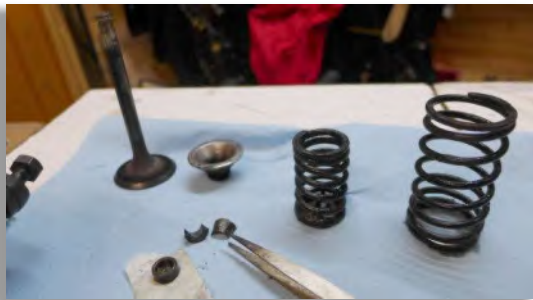
Figure 90: The dismantled valve components. Note the two collets which hold the valve in the spring via the cone dish.

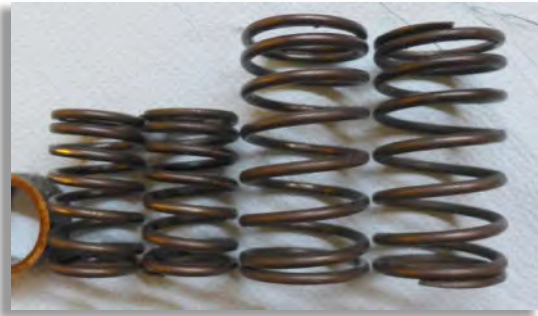
Figure 92: All inner and outer valve springs.

Ideally the valve springs should be replaced with new ones. However, this is difficult because replacement is no longer available on the market. Here the Sunbeam Club or, as with us, a generous Sunbeam colleague can help. In order to find suitable valve springs, their dimensions such as total length, outer and wire diameter and the distance between the coils are not sufficient (Fig. 92).

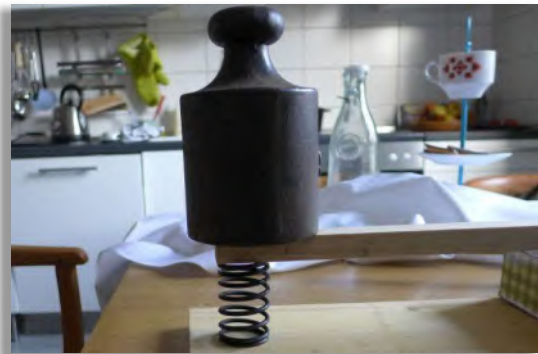
Figure 93: Measuring the spring constant with a market weight.

One also needs to know the material or the spring constant. It tells how strongly a spring is compressed by a force acting on it and is given in Newton per meter. This length can be measured by placing a weight on the spring. Without going into the physical details, a spring that is compressed by a weight of one kilogram by one centimeter has a spring constant of about 1.000 Newton per meter (N/m)¹¹. We put a 5Kg market weight on the springs and then measured the length that they are compressed (Fig. 93). This resulted in approximately 6,100 N/m and 11,000 N/m for the outer and inner valve springs. For the springs donated by a fellow Sunbeam owner, approximately 8,175 N/m and 11,000 N/m were determined. The one third higher spring constant of the outer spring is not a problem, as this means that the load on the push rods is only 10% higher when the two springs are combined.

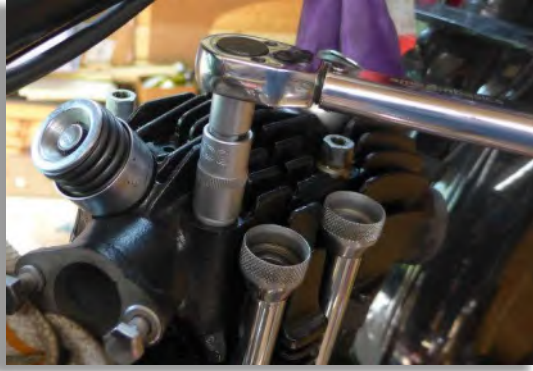
Figure 95: The 7/16 inch bolts are carefully tightened crosswise with a torque wrench.

rocker arm shaft is fixed to the rocker arm and is not designed to come loose. Hence, we only washed them thoroughly with paraffin which was enough to make them easy again. Finally, we painted the head as we did for the cylinder, assembled the valves and install it again (Fig. 95). For the 7/16" head bolts we give 37 lb·ft (48 Nm) as required according to figure 58.

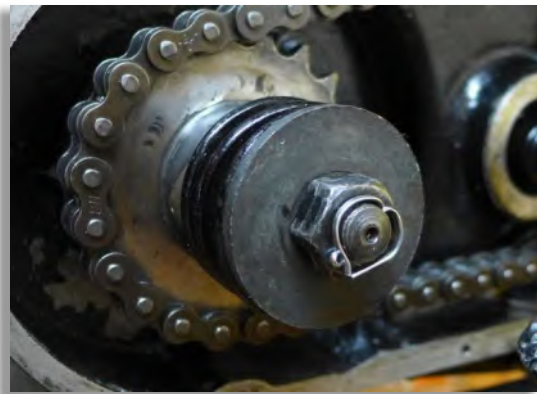
Figure 98: The cush drive is secured with a new cotter pin.

The horn can be assembled again as can the carburettor. Because of easier access it is recommended to re-connect the clutch cable to the gear box lever before attaching the oil pipes. When assembling the primary chain case again do not forget to secure the cush drive with a new cotter pin (Fig. 98). Finally, the tank and the saddle can be assembled. After filling the oil and fuel tanks as well as the primary chain case and after connecting wiring we recommend to kick the motor over for some dozen kicks to pre-oil the internal lubrication points.

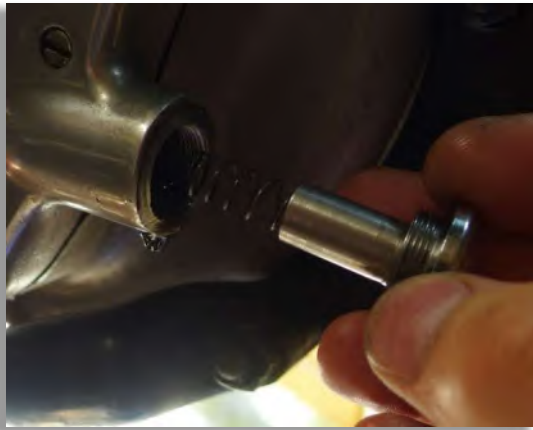
Figure 99: The screw and spring of the ball valve.

Such a large amount of oil can only come directly from the oil tank. Since we had left the oil pump untouched, the ball valve was suspect. It ensures that oil only enters the system at a certain pressure, thus preventing unwanted oil flow into the crankcase. The valve is located in the lower valve cover in the direction of travel (on earlier models, the tell tale was located here, which had been abandoned in favor of the oil pressure gauge – Fig. 99). It consists of the screw, which carries a spring. The spring in turn presses a ball of 9.02mm diameter (23/64 thou?) against the opening of the oil supply from the oil tank. The assembly is encased in a brass mesh oil filter¹² (Fig. 100).

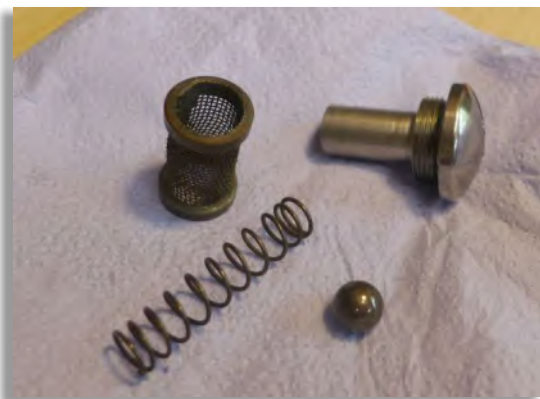
Figure 100: All parts of the ball valve.

Some oil sludge had accumulated in the filter and this had probably prevented the ball from completely closing the opening at rest. Probably the magnet in the oil drain plug (Fig. 71) had not caught all the chips, or the material had been moved when the pump assembly was flushed in-situ. After a thorough cleaning, the unwanted oil flow was stopped.

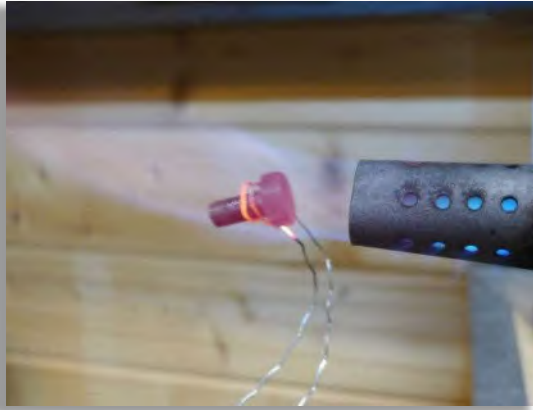
Figure 101: Heating a bolt for blueing it.

- **Screws and bolts** are usually primed and painted black. When bolts are worn, they then look accordingly. Instead of repainting them, they can be blueed. To do this, the metal is heated (Fig. 101) and then quenched with linseed oil. The result is a clean matt black surface (Fig. 102).

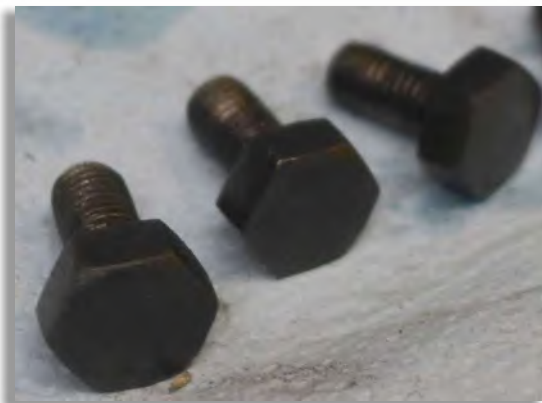
Figure 102: blueed bolts

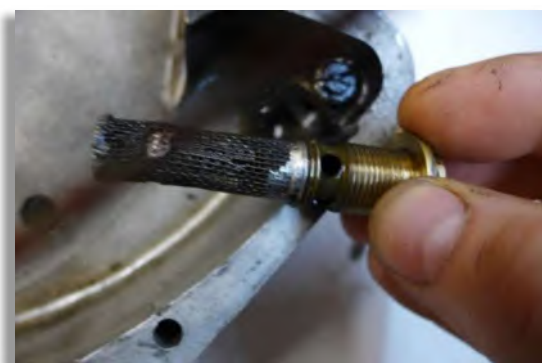
Figure 103: The old damaged sump oil filter.

- **The oil sump filter** out of brass should be washed out regularly with fuel every time the oil is changed. In our case, it was damaged (Fig. 103) and therefore had to be replaced. We changed the mesh with a size of about 1mm to one of 0.5mm and soldered it to the oil drain plug (Fig. 104).

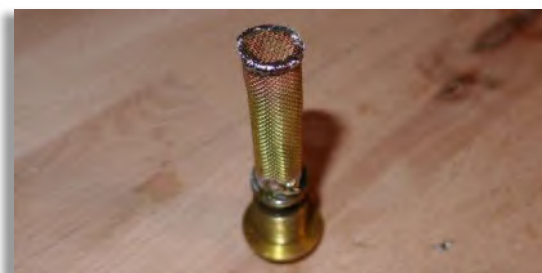
Figure 104: The soldered brass filter with a smaller mesh width.
